# LEMHI COUNTY AIRPORT

This report describes how your pavement maintenance management program was developed. This program was developed as part of the Network Pavement Management Program project sponsored by the Idaho Transportation Department, Division of Aeronautics. The information and data contained in this report ensures you are in compliance with the requirements of Federal Aviation Administration (FAA) Grant Assurance Number 11 which states that any airport requesting federal funds for pavement improvement projects must have implemented a pavement maintenance management program (PMMP).

Using the branch, section and sample unit divisions established, a visual condition survey was conducted at Lemhi County Airport on October 31, 2006. During the inspection pavement defects were identified and measured in accordance with the methodology outlined in FAA AC:150/5380-6 and ASTM D5430. Our inspection ensures your airport complies with the “detailed inspection” requirement of FAA’s PMMP guidelines. After collection, the data were entered into the Micro PAVER software for analysis. These data are reproduced in the Re-Inspection Report attached in Appendix 2. Photographs of typical

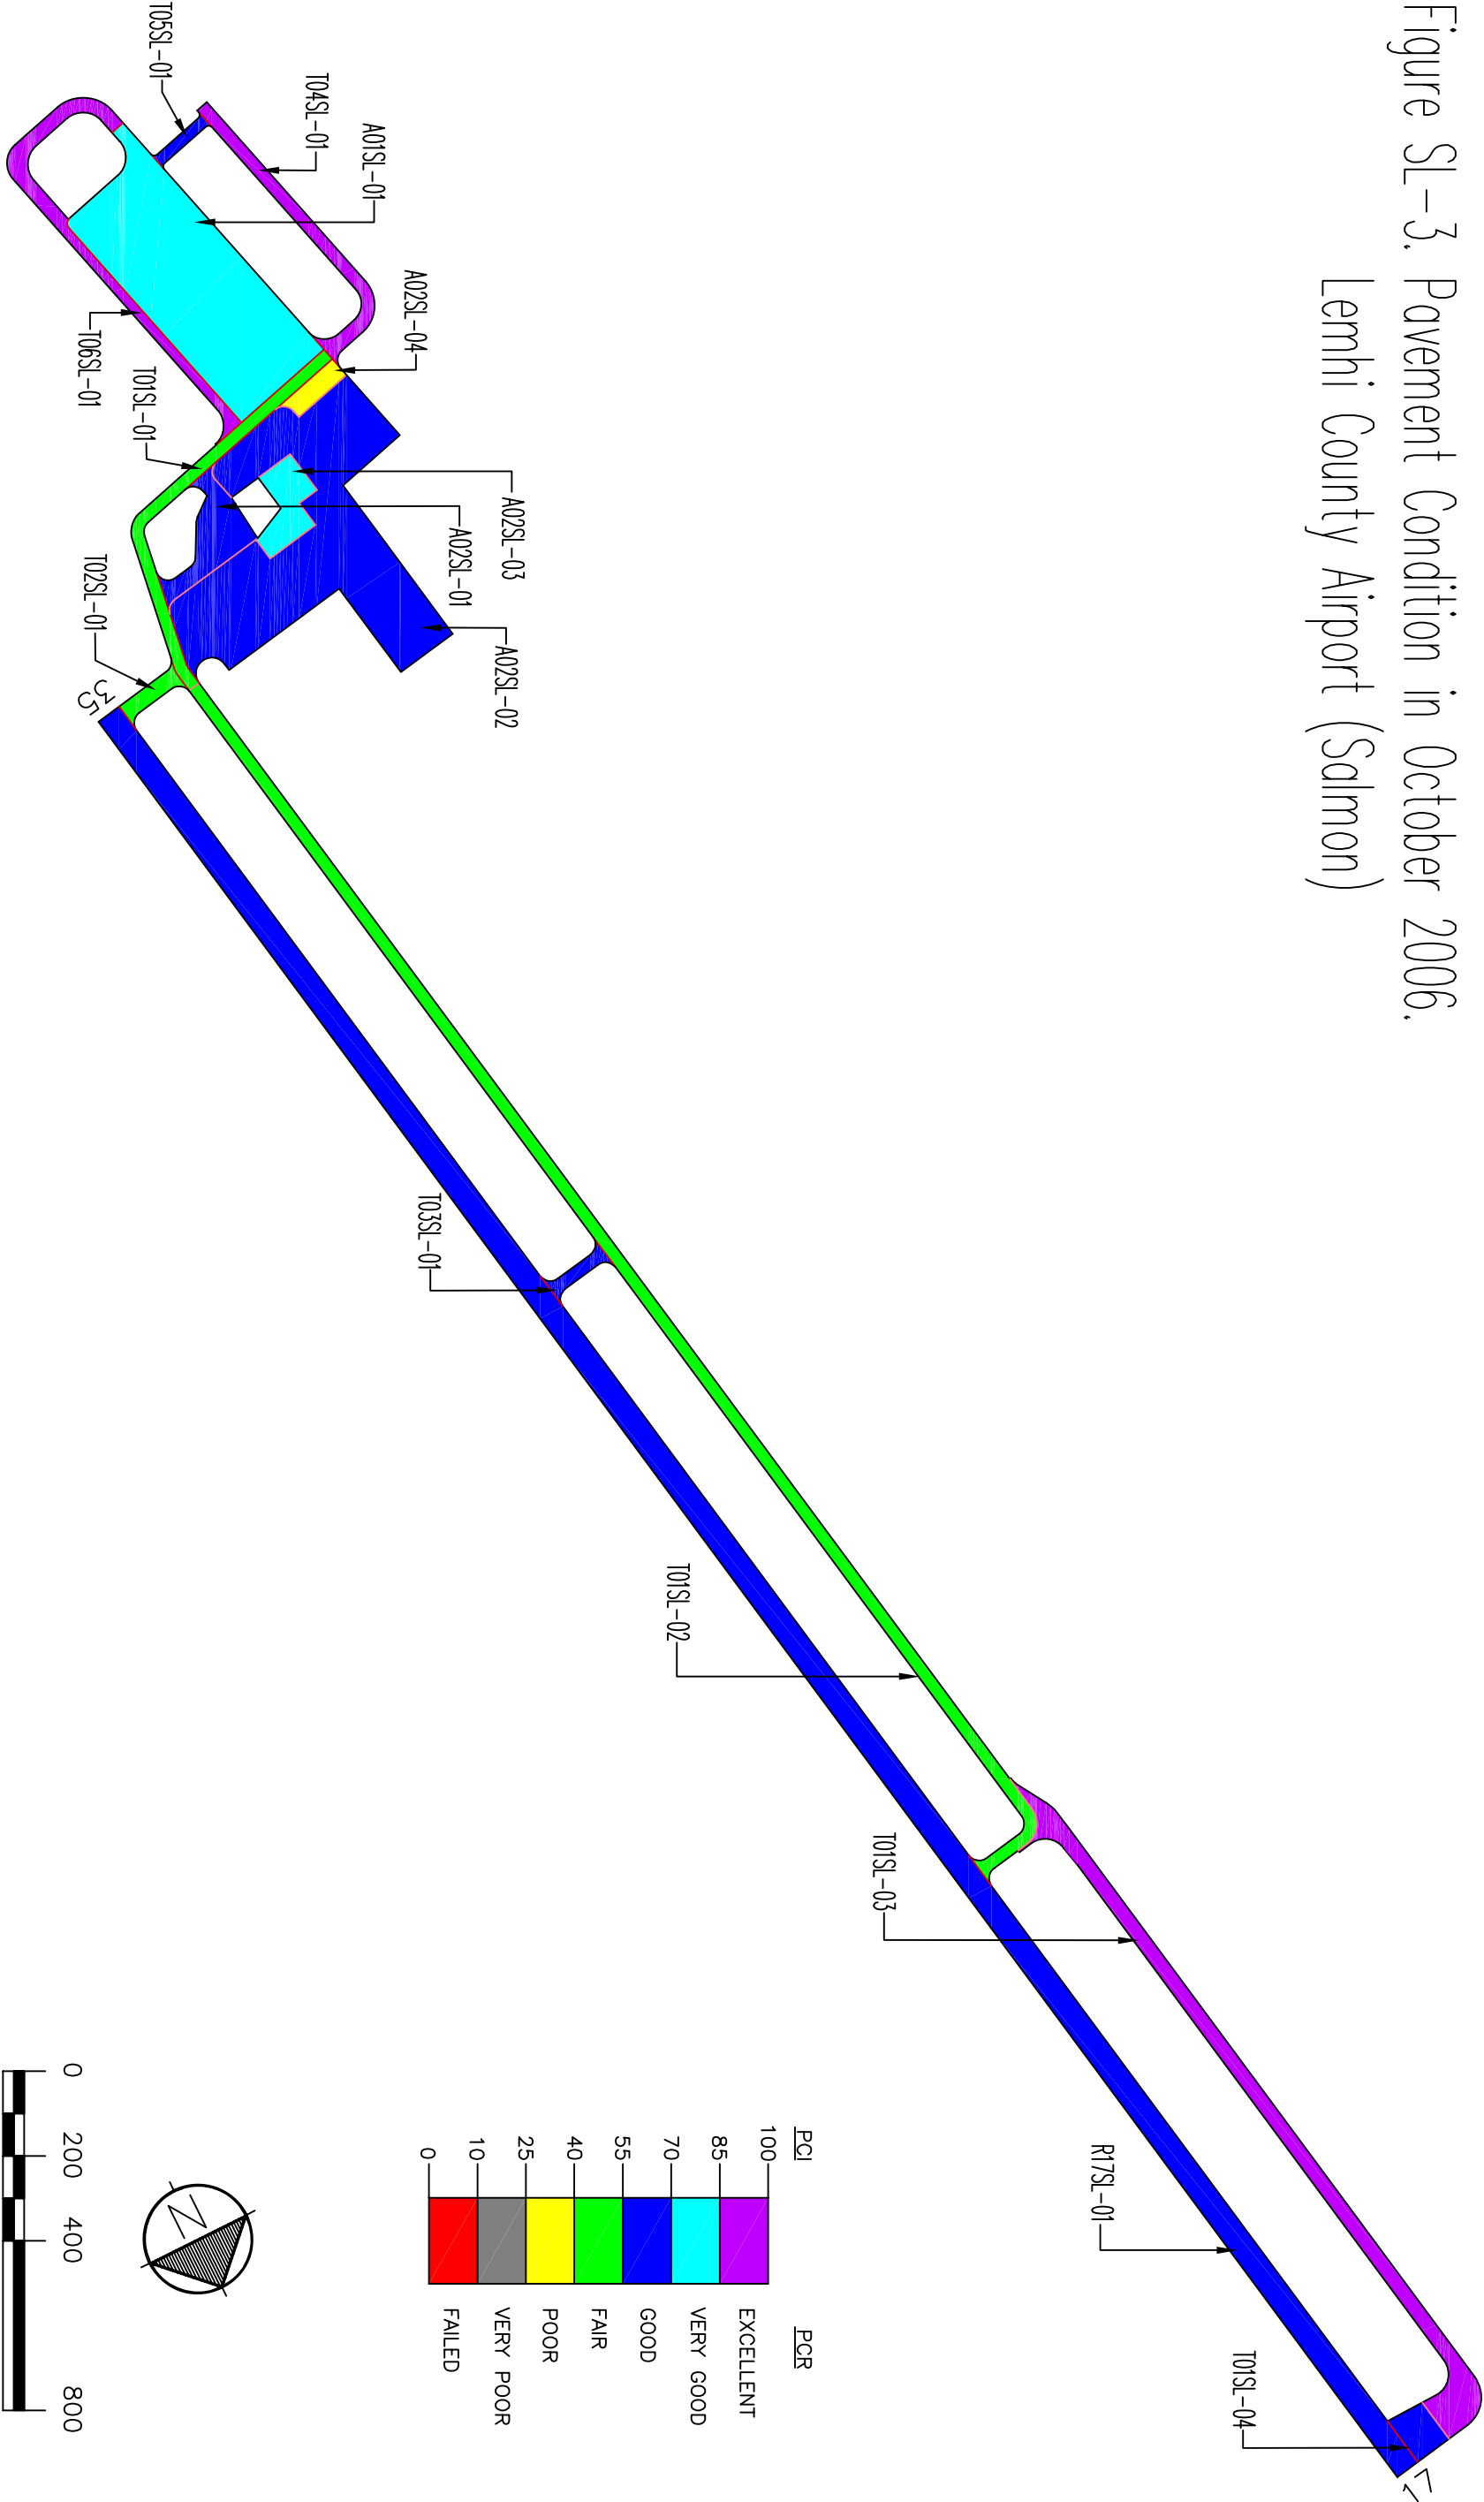
Figure SL-3. Pavement Condition in October 2006.  
Lemhi County Airport (Salmon)

Section PCIs at the airport range from a low of 36 (a PCR of "Poor") to a high of 100 (a PCR of "Excellent"). The area-weighted average PCI for all airport pavements is 66, corresponding to an overall PCR of "Good". Figure SL-4 shows how much pavement area is associated with each Pavement Condition Rating category and also shows pavement condition distribution from the inspections conducted in 1997 and 2000. A graphical representation of the projected PCRs presented in Table SL-2 is shown in Figure SL-5.

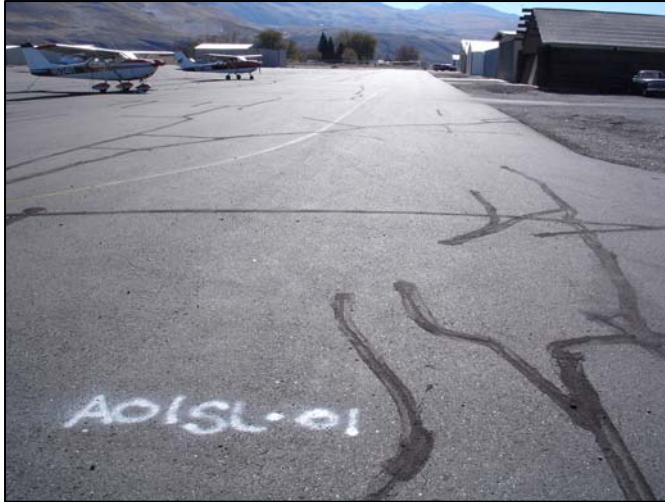
Sample Number: 13 Type: R Area: 5,000.00SqFt PCI = 71  
48 LONGITUDINAL/TRANSVERSE CRACKING L 250.06 Ft  
48 LONGITUDINAL/TRANSVERSE CRACKING M 150.04 Ft  
45 DEPRESSION L 162.00 SqFt

Section: A01SL-01  
Longitudinal/ Transverse Cracking

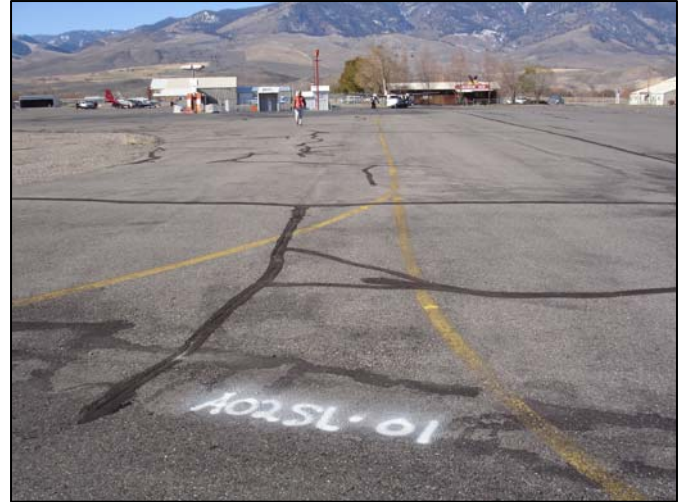
Sample Number: 01	Type: R	Area: 6,883.00SqFt	PCI = 49
45 DEPRESSION	L	68.00 SqFt	
48 LONGITUDINAL/TRANSVERSE CRACKING	L	278.07 Ft	
48 LONGITUDINAL/TRANSVERSE CRACKING	M	280.07 Ft	
52 WEATHERING/RAVELING	H	246.00 SqFt

Section: A02SL-01  
Longitudinal/ Transverse Cracking

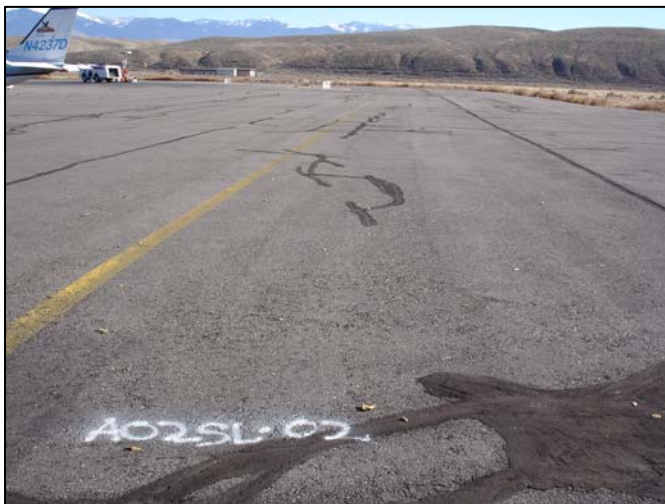
Sample Number: 02	Type: R	Area:	5,000.00SqFt	PCI = 69
43 BLOCK CRACKING		L	999.99 SqFt	
43 BLOCK CRACKING		M	100.00 SqFt	
45 DEPRESSION		L	48.00 SqFt

Section: A02SL-02  
Block Cracking  
Longitudinal/ Transverse Cracking

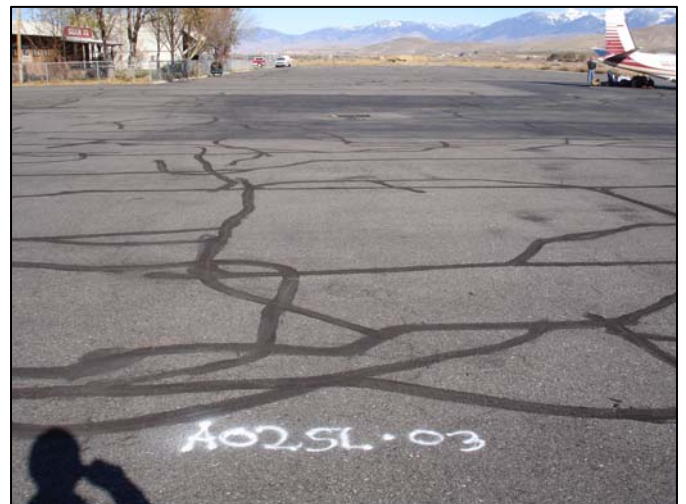
Sample Number:	01	Type:	R	Area:	5,297.00SqFt	PCI = 65
43	BLOCK CRACKING			L	1,799.99 SqFt	
48	LONGITUDINAL/TRANSVERSE CRACKING			L	740.19 Ft	
Sample Number:	02	Type:	R	Area:	4,750.00SqFt	PCI = 78
48	LONGITUDINAL/TRANSVERSE CRACKING			L	300.08 Ft	
48	LONGITUDINAL/TRANSVERSE CRACKING			M	94.02 Ft	
Sample Number:	03	Type:	R	Area:	8,723.00SqFt	PCI = 71
43	BLOCK CRACKING			L	1,743.99 SqFt	
43	BLOCK CRACKING			M	871.99 SqFt

Section: A02SL-03  
Block Cracking  
Longitudinal/ Transverse Cracking

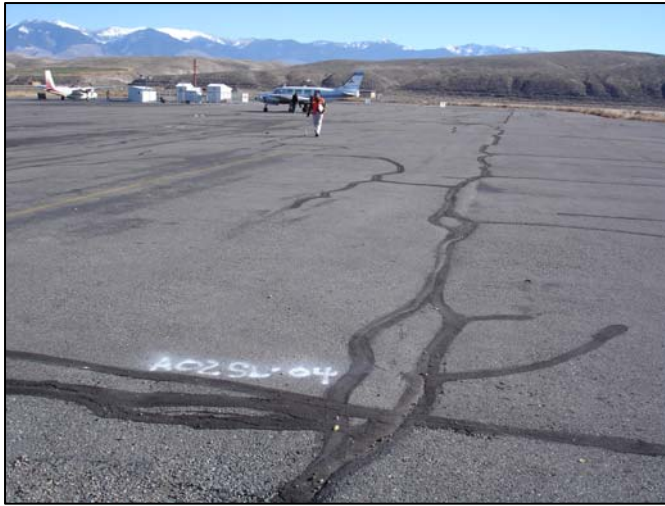
Sample Number:	01	Type:	R	Area:	5,000.00SqFt	PCI = 39
42	BLEEDING			N	1,047.99 SqFt	
48	LONGITUDINAL/TRANSVERSE CRACKING			L	300.08 Ft	
48	LONGITUDINAL/TRANSVERSE CRACKING			M	114.03 Ft	
Sample Number:	02	Type:	R	Area:	2,693.00SqFt	PCI = 29
42	BLEEDING			N	839.99 SqFt	
45	DEPRESSION			L	84.00 SqFt	
48	LONGITUDINAL/TRANSVERSE CRACKING			L	200.05 Ft	
48	LONGITUDINAL/TRANSVERSE CRACKING			M	20.01 Ft

Section: A02SL-04  
Bleeding  
Longitudinal/ Transverse Cracking

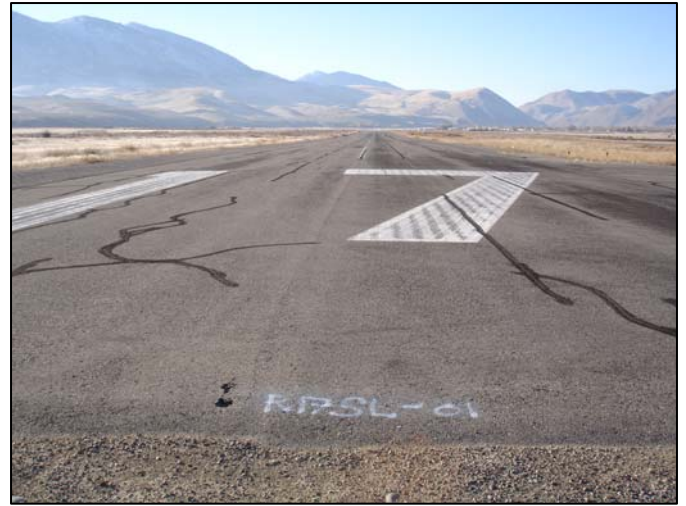
Sample Number: 01 Type: R Area: 6,000.00SqFt PCI = 45  
42 BLEEDING N 869.99 SqFt  
48 LONGITUDINAL/TRANSVERSE CRACKING L 354.09 Ft  
48 LONGITUDINAL/TRANSVERSE CRACKING M 62.02 Ft

Section: R17SL-01  
Bleeding  
Longitudinal/ Transverse Cracking  
Weathering/ Raveling

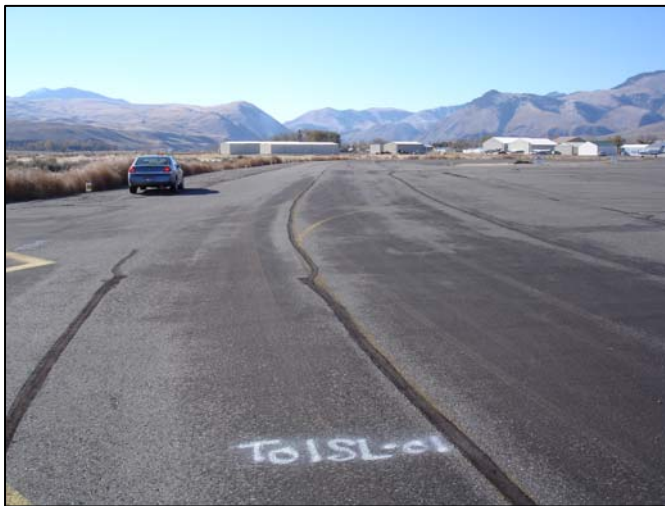
Section: T01SL-01  
Bleeding  
Longitudinal/ Transverse Cracking

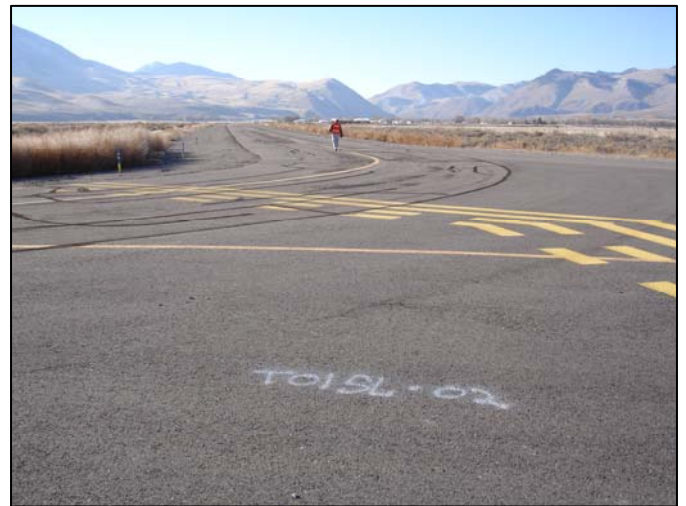
Section: T01SL-02  
Bleeding

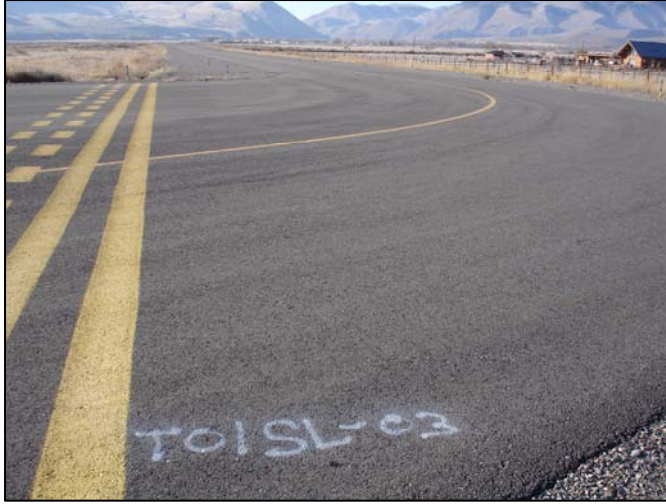
Section: T01SL-03  
No Distress

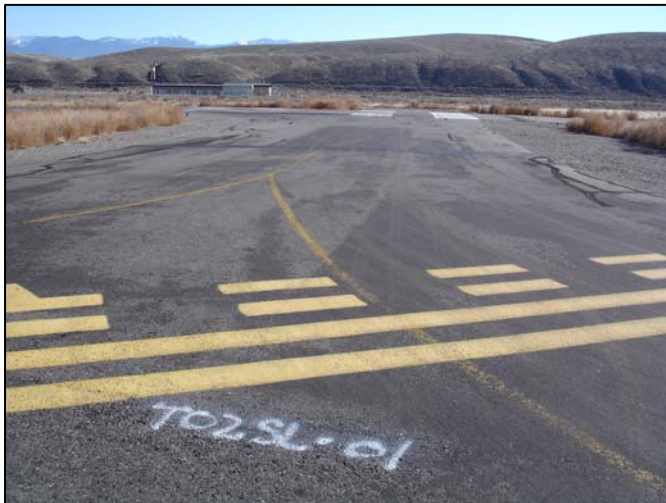
Sample Number:	01	Type:	R	Area:	6,715.00SqFt	PCI = 43
42	BLEEDING			N	849.99 SqFt	
48	LONGITUDINAL/TRANSVERSE	CRACKING		L	431.11 Ft	
48	LONGITUDINAL/TRANSVERSE	CRACKING		M	95.02 Ft	
52	WEATHERING/RAVELING			H	2.00 SqFt

Section: T02SL-01  
Bleeding

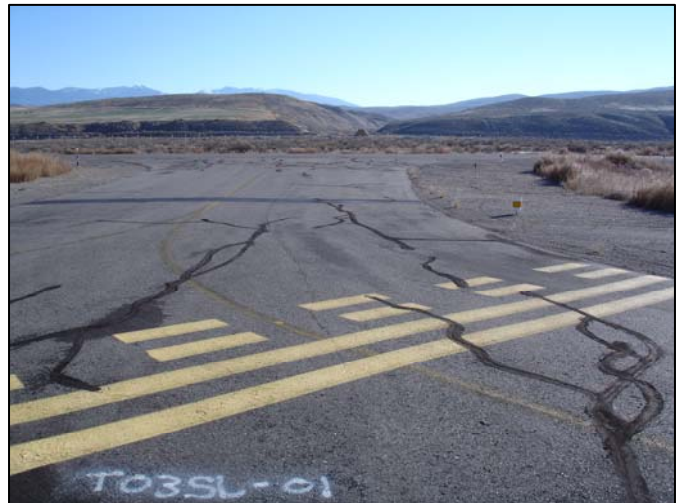
Sample Number:	01	Type:	R	Area:	5,422.00SqFt	PCI =	56
42	BLEEDING			N	356.00 SqFt		
48	LONGITUDINAL/TRANSVERSE CRACKING			L	922.24 Ft		
48	LONGITUDINAL/TRANSVERSE CRACKING			M	23.01 Ft

Section: T03SL-01  
Bleeding  
Longitudinal/ Transverse Cracking

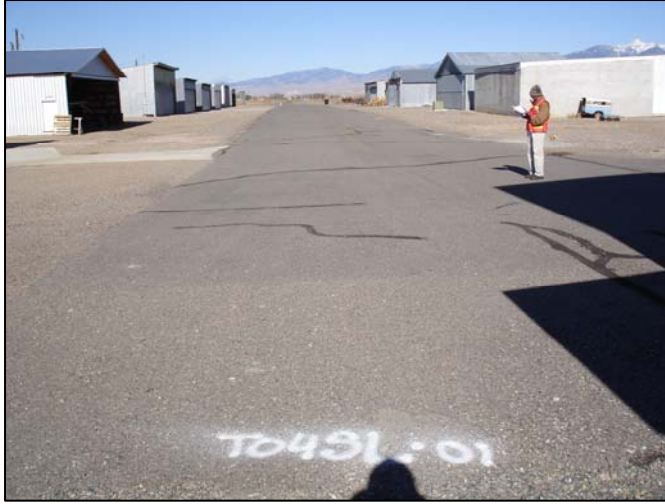
Sample Number:	01	Type:	R	Area:	6,000.00SqFt	PCI = 81
48	LONGITUDINAL/TRANSVERSE	CRACKING	L	271.07	Ft	
48	LONGITUDINAL/TRANSVERSE	CRACKING	M	20.01	Ft	
Sample Number:	02	Type:	R	Area:	6,000.00SqFt	PCI = 92
48	LONGITUDINAL/TRANSVERSE	CRACKING	L	126.03	Ft	
Sample Number:	03	Type:	R	Area:	6,000.00SqFt	PCI = 87
48	LONGITUDINAL/TRANSVERSE	CRACKING	L	136.03	Ft	
48	LONGITUDINAL/TRANSVERSE	CRACKING	M	10.00	Ft

Section: T04SL-01  
Longitudinal/ Transverse Cracking

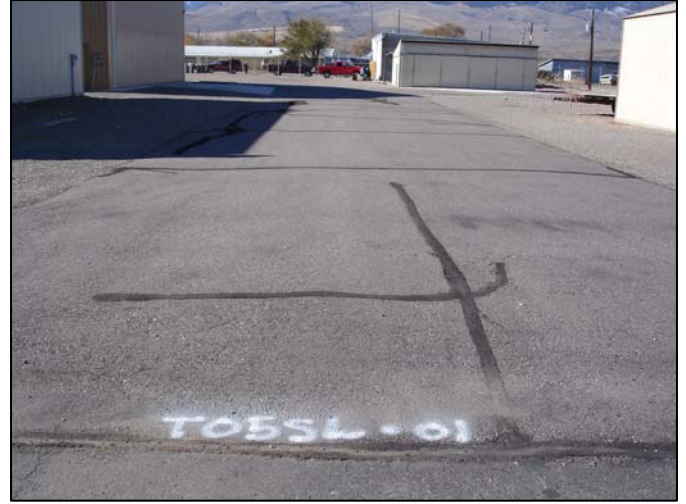
Sample Number:	01	Type:	R	Area:	4,136.00SqFt	PCI = 61
45	DEPRESSION			L	88.00 SqFt	
48	LONGITUDINAL/TRANSVERSE	CRACKING		L	225.06 Ft	
52	WEATHERING/RAVELING			H	71.00 SqFt	
48	LONGITUDINAL/TRANSVERSE	CRACKING		M	100.03 Ft

Section: T05SL-01  
Longitudinal/ Transverse Cracking
